Manhole Inspection Summary

Manhole # S25CC1014MH

Location Address: **3700 FALLS RD**

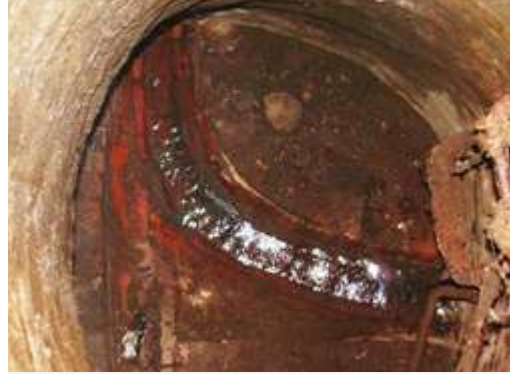
Top View

Corroded steps. Evidence of surcharge - Bench debris.

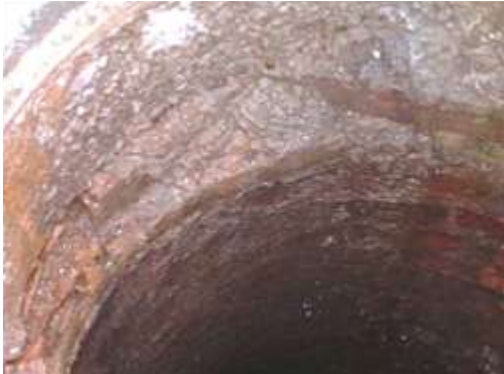
Defect

Condition: ☐ Sound ☐ Cracked ☒ **Leaks**

Condition: ☐ Sound ☐ Cracked ☐ Root Intrusion ☐ Loose Brick ☒ **Deteriorated**

Infiltration: ☐ None ☒ **Joint** ☐ Cracks ☒ **Mortar** ☐ Roots ☐ Wall

Frame leaks. Frame offset. Adjustment deterioraton and infiltration.

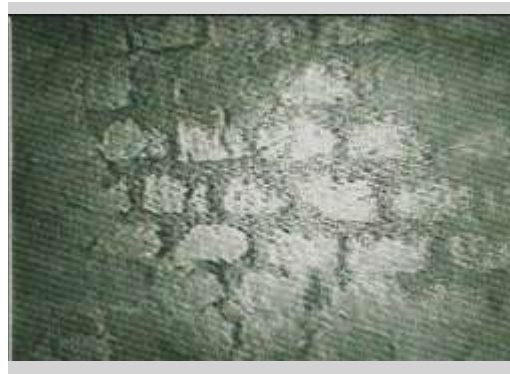
Defect

Infiltration: ☐ None ☐ Joint ☐ Cracks ☒ **Mortar** ☐ Roots ☐ Wall

Barrel infiltration.

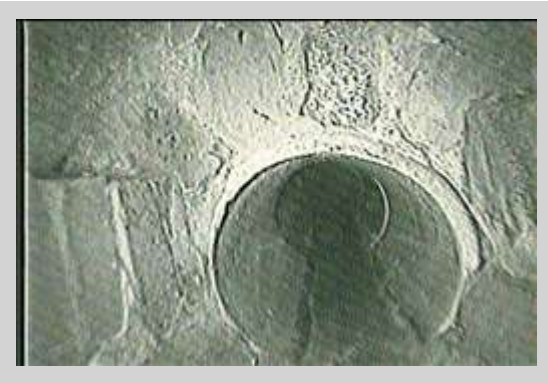
8 in. Circular Gravity Sewer Pipe Out @ 12 O'Clock

Channel deterioration.

Infiltration: **Evidence**

Pipe Seal Cond: **Cracked**

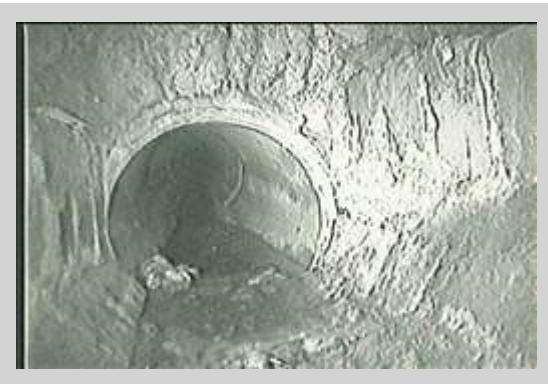
8 in. Circular Gravity Sewer Pipe In @ 4 O'Clock

Barrel deterioration and infiltration.

Deposits: ☐ None ☐ **Mud** ☐ Sludge ☒ **Debris** ☒ **Grease**

Infiltration: **Evidence**

Pipe Seal Cond: **Cracked**

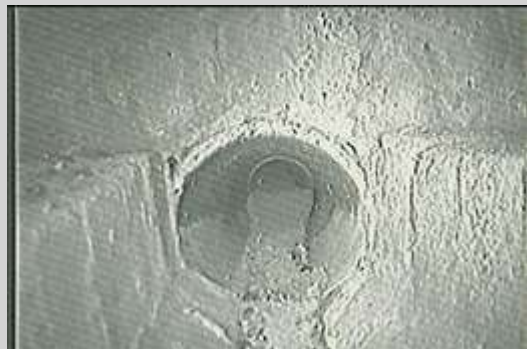
6 in. Circular Gravity Sewer

Deposits: ☐ None ☒ **Mud** ☐ Sludge ☒ **Debris** ☐ Grease

Silt Depth: **3** (in.)
